PROJECT MEMORANDUM
SCE WEST OF DEVERS UPGRADE PROJECT

Date: November 20, 2018
To: Billie Blanchard, Project Manager, CPUC
From: Vida Strong, Aspen Project Manager
Subject: Monitoring Report #40: November 5 to November 11, 2018

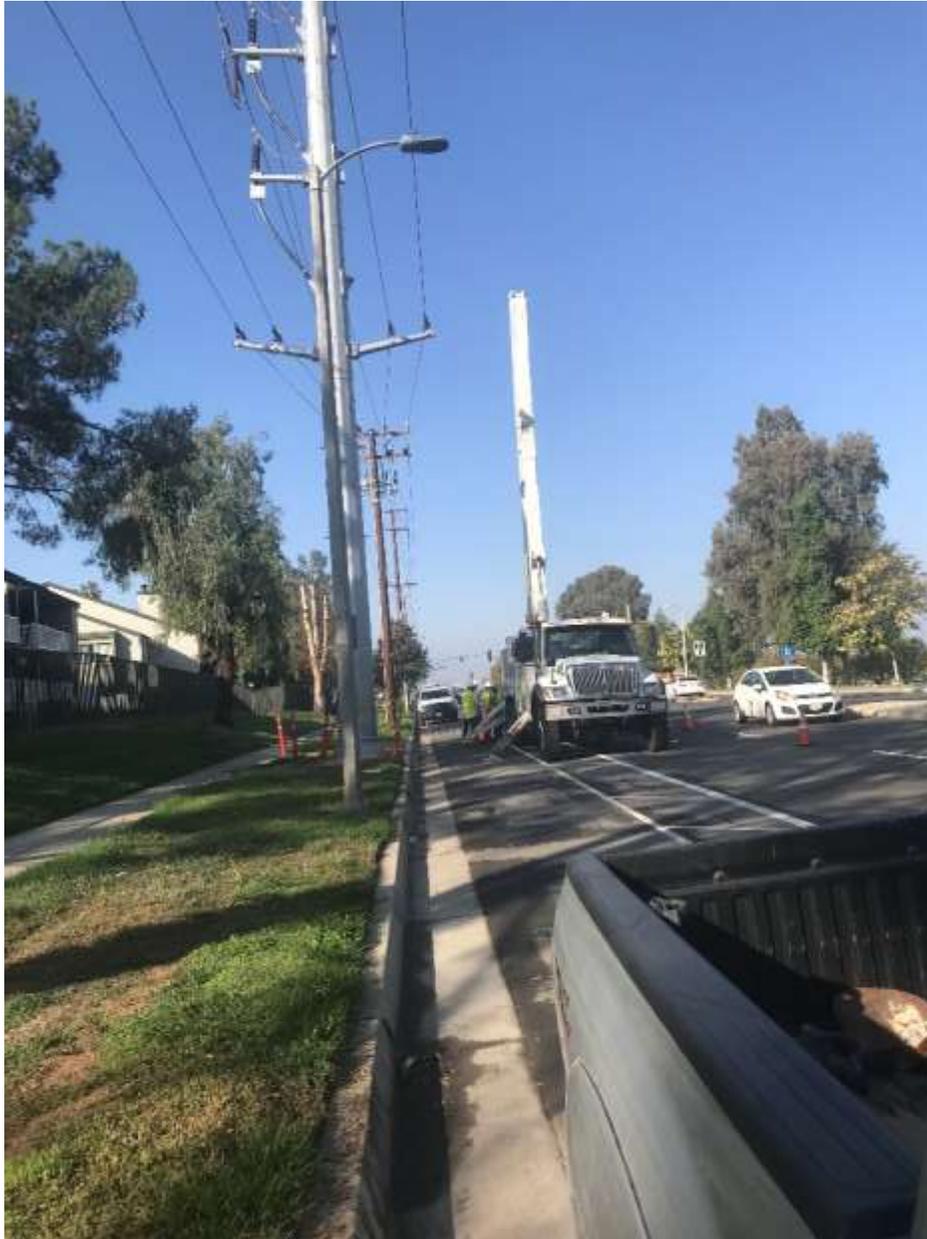
Photo 1 – Subtransmission cutover work along Barton Road in Redlands.
(November 8, 2018).

7. Distribution work associated with the Dental and Intern Circuits included trenching, vault racking, splicing, and inter duct installation.
8. Work associated with the Timoteo Relocation subtransmission improvements included cutover operations at Mountain View Ave, wire clipping, and landscape restoration (see Photo 1).

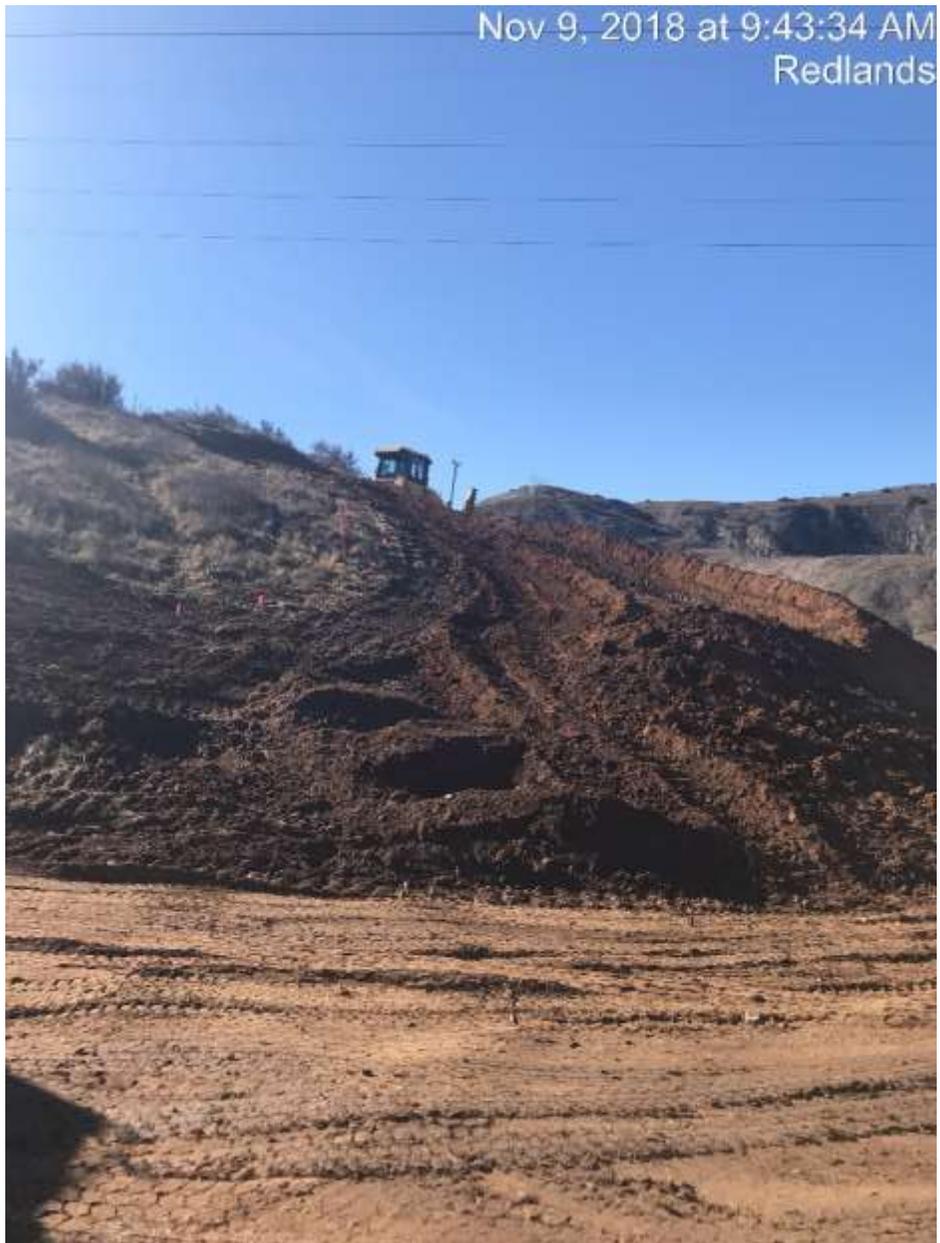
Photo 2 – Grading at Site 3X62 in preparation of foundations and tower installation, work performed by Power Grade (November 9, 2018).

3. Work associated with Segment 2 was limited to mowing and BMP installation at Site 2N32.
4. Work associated with Segment 3 included retaining wall construction at Site 3X37. Foundation drilling and pouring was performed at Sites 3X19, 3X21, and 3X22. Steel delivery occurred at Sites 3X14-3X16. Grading occurred at Site 3X62 (see Photo 2).

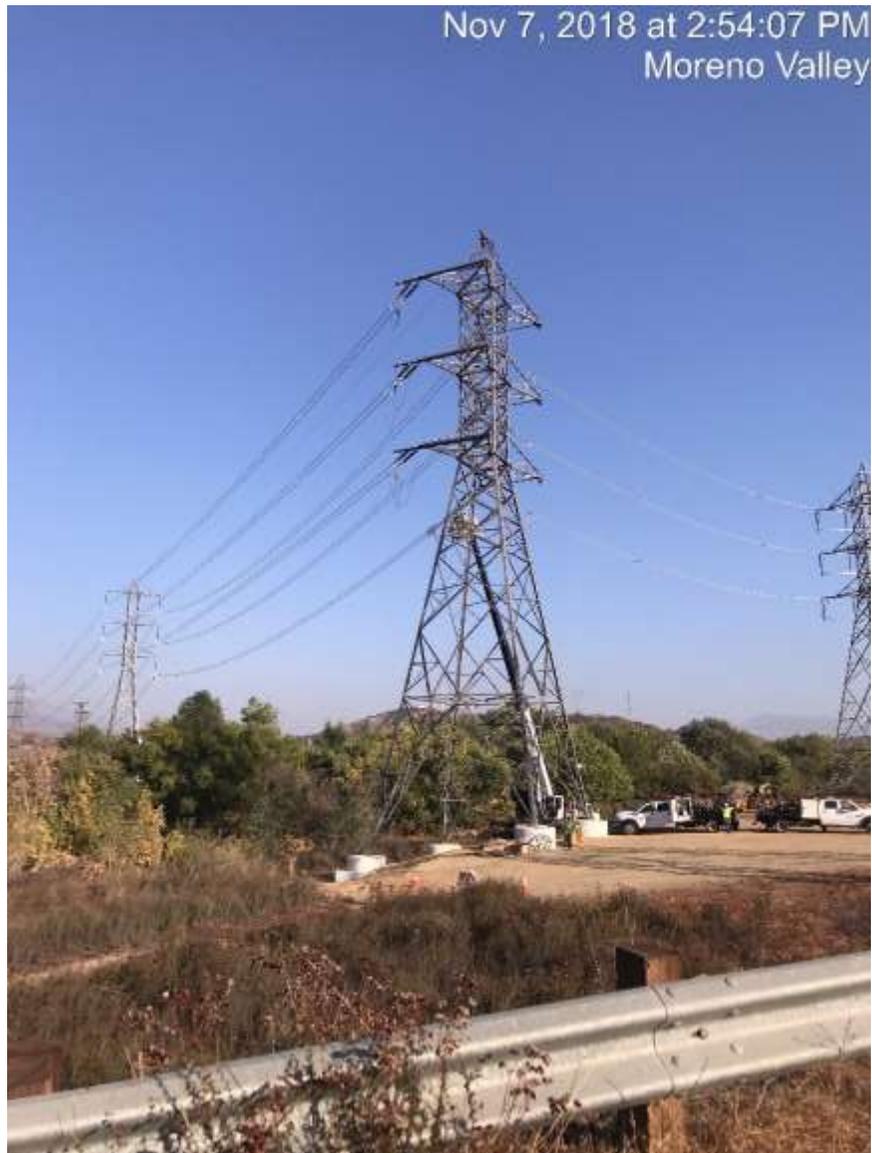
Photo 3 – Wire installation as part of the current outage at Segment 4, Site 4N64 (November 7, 2018).

5. Work associated with Segment 4 included tower and foundation removal along with wire installation. Work associated with the outage continued with wire stringing activities occurred between Site 4X55 and El Casco Substation via helicopter (see Photo 3).

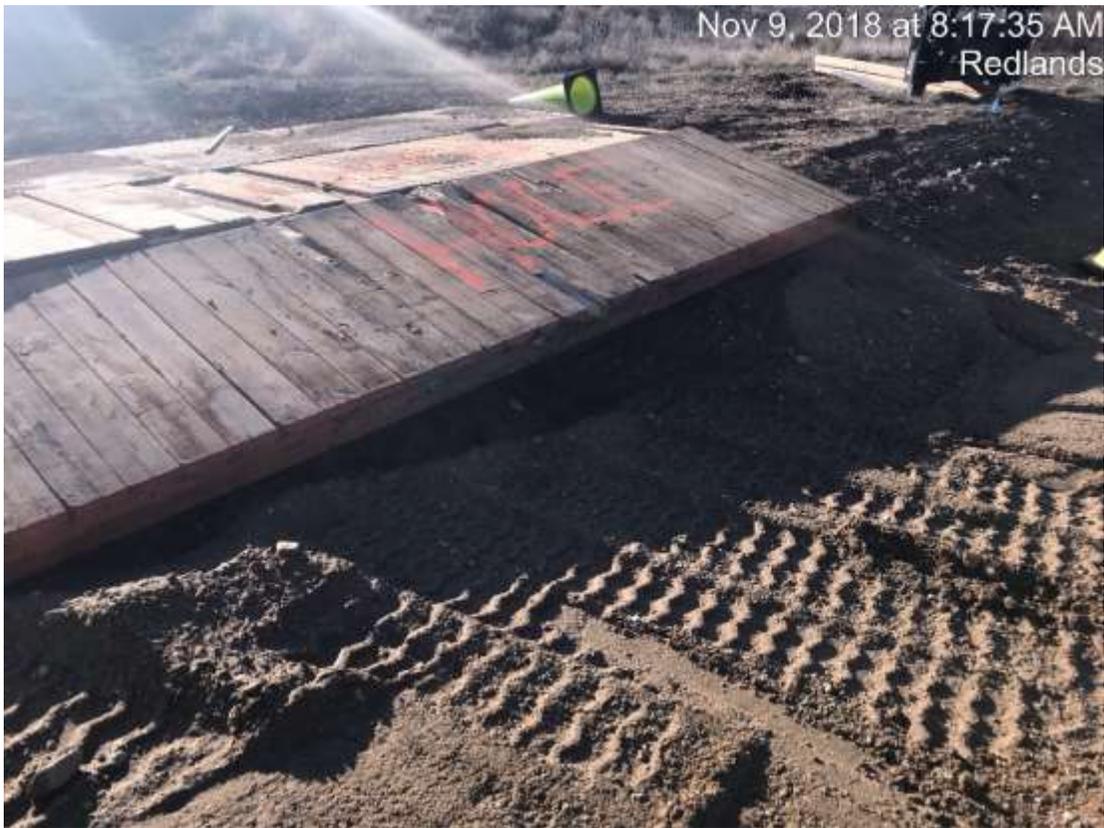
1. One SCE self-reported and no CPUC incidents documented for construction activities associated with NTP #4 throughout the monitoring period. On November 9, the CPUC EMs noted that foundation holes at Site 3X22 were left inadequately covered over the previous night; the location is mapped as suitable habitat for Stephens kangaroo rat, a CDFW covered species (see Photo 4). The CPUC Lead EM notified the Biological Monitor who came to the site to assess the situation. The Biological Monitor subsequently documented the issue as a Level 1 compliance incident because it conflicts with Mitigation Measure WIL-1b, Ensure Wildlife Impact Avoidance and Minimization.

Photo 4 – The CPUC EMs noted a large gap in the foundation hole cover at Segment 3, Site 3X22. The hole had been left overnight with inadequate cover, creating a hazard for wildlife entrapment. (November 9, 2018).
